**Flood Control Project Maintenance
Levee Inspections
LMA District Cover Sheet
Spring 2012 Levee Inspection Results**

Reclamation District No. 0536 Egbert

Spring 2012 Levee Inspection Results

Waterway		Bank	Unit Miles
Unit No. 01 Lindsey Slough		Right	5.66

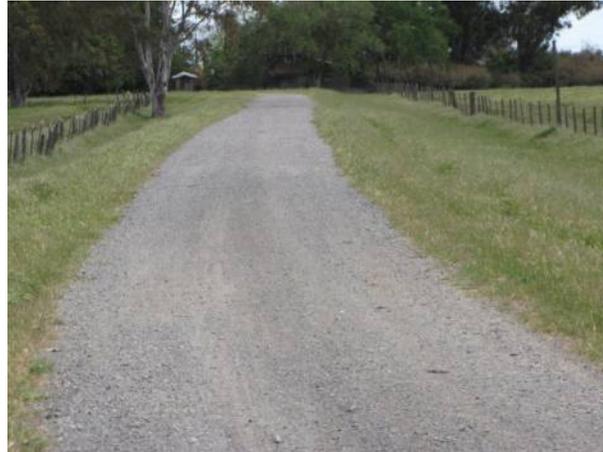
Levee Mile Report Line	5
Start Levee Mile	0.00
End Levee Mile	0.00
Location	Water Side
Category	Earthen Levee
Item	Vegetation
Levee mile 0.00 looking downstream Unit 1 RD536. Photo taken 4-24-2012.	
phillips_s_20120524_464.jpg

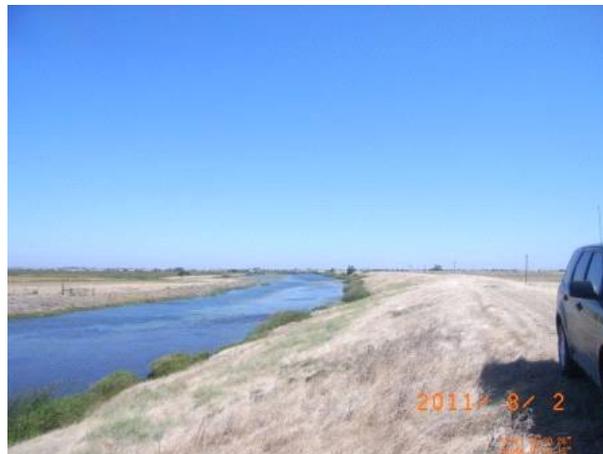
Levee Mile Report Line	8
Start Levee Mile	0.52
End Levee Mile	0.88
Location	Water Side
Category	Supplemental
Item	USACE Erosion Survey
USACE 2011 Photo #1	
phillips_s_20120306_204.jpg

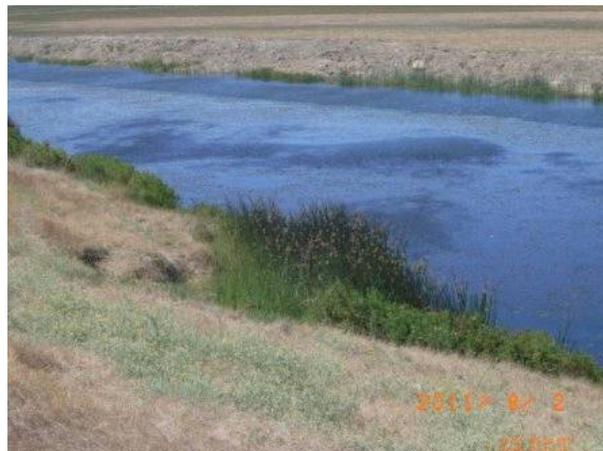
Levee Mile Report Line	8
Start Levee Mile	0.52
End Levee Mile	0.88
Location	Water Side
Category	Supplemental
Item	USACE Erosion Survey
USACE 2011 Photo #2	
phillips_s_20120306_205.jpg

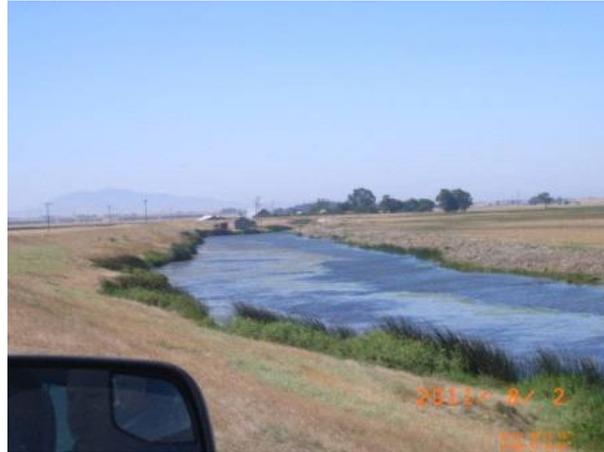
USACE 2011 Photo #3

Levee Mile Report Line	8
Start Levee Mile	0.52
End Levee Mile	0.88
Location	Water Side
Category	Supplemental
Item	USACE Erosion Survey

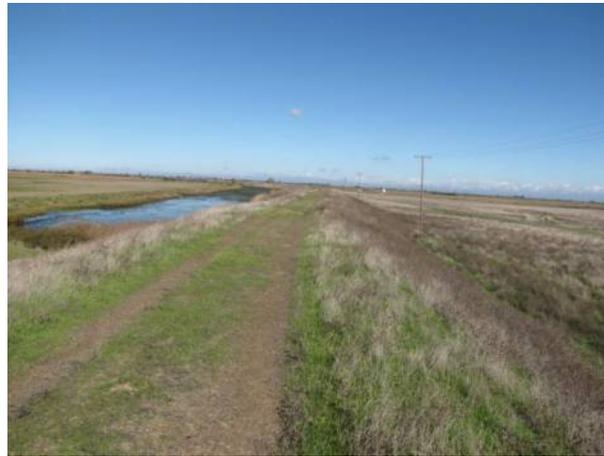
View of levee section Unit 1 RD 536 looking downstream, grasses cover the crown and both levee slopes land side and waterside levee mile 0.64. Photo taken 11-10-2010

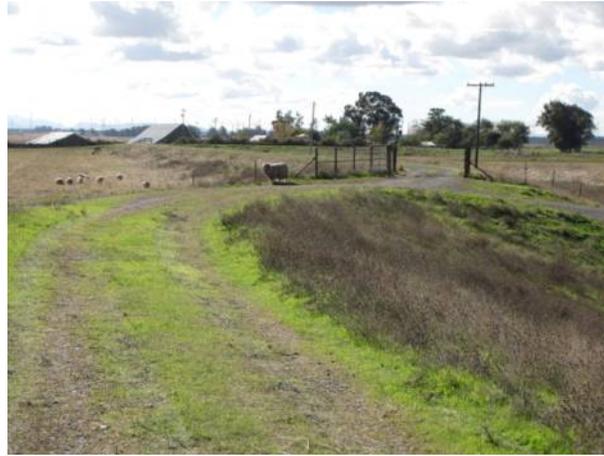
View of levee section RD 536 Unit 1 looking upstream from levee mile 0.64 waterside. Photo taken 11-20-2010

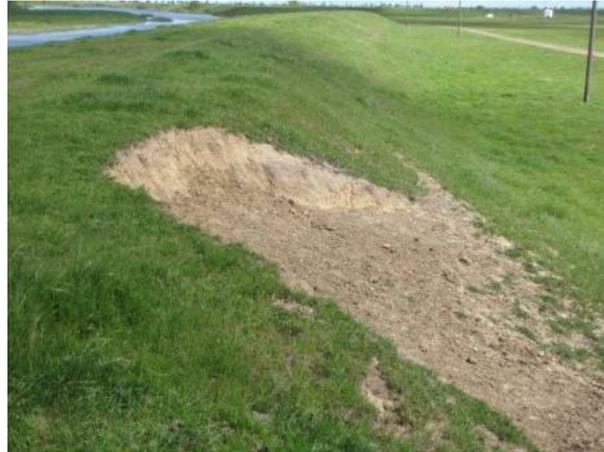
Levee Mile Report Line	13
Start Levee Mile	0.74
End Levee Mile	0.75
Location	Land Side
Category	Earthen Levee
Item	Erosion / Bank Caving
New erosion site located at levee mile 0.74 (38.25054 -121.759392 to 38.250543 - 121.759387. Photo taken 4-7-2011.	
phillips_s_20120306_199.jpg

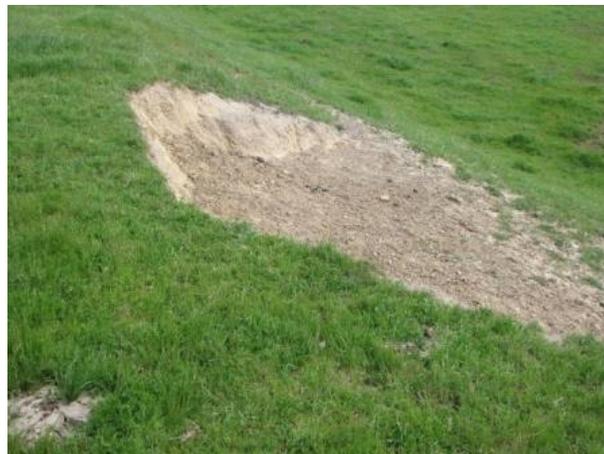
Levee Mile Report Line	13
Start Levee Mile	0.74
End Levee Mile	0.75
Location	Land Side
Category	Earthen Levee
Item	Erosion / Bank Caving
Another view of the erosion along the landside slope levee mile 0.74.	
phillips_s_20120306_200.jpg

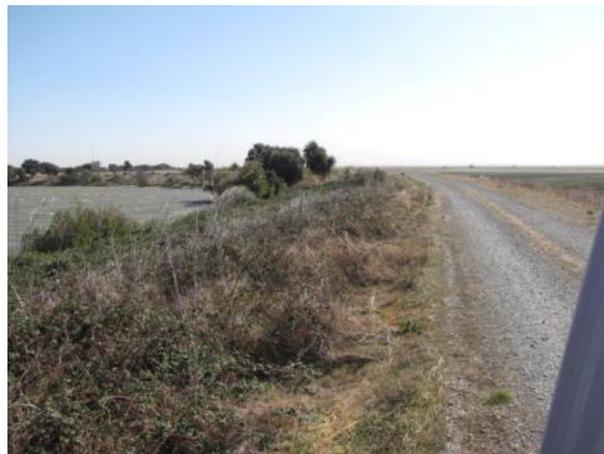
Levee Mile Report Line	14
Start Levee Mile	0.93
End Levee Mile	4.28
Location	Water Side
Category	Earthen Levee
Item	Vegetation
Looking downstream from levee mile 4.29 unit 1 waterside. Photo taken 11-01-2011.	
phillips_s_20120306_218.jpg

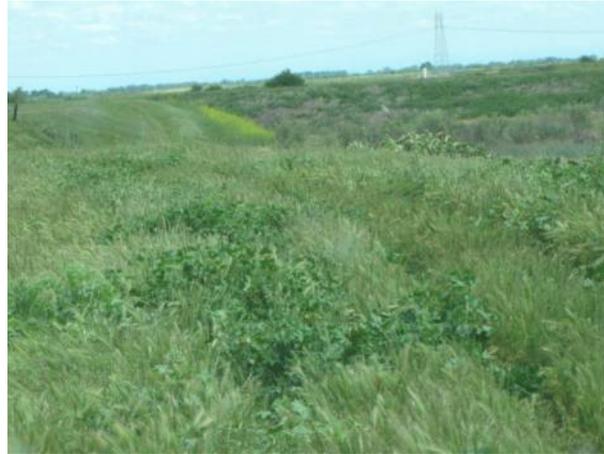
Levee Mile Report Line	16
Start Levee Mile	1.56
End Levee Mile	2.24
Location	Crown
Category	Earthen Levee
Item	Vegetation
RD 536 Levee mile 1.58 crow roadway. Photo taken 4-24-2012.	
phillips_s_20120524_461.jpg

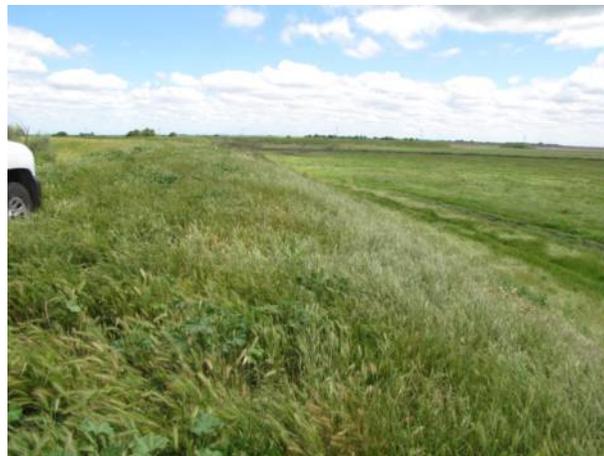
Levee Mile Report Line	17
Start Levee Mile	1.56
End Levee Mile	2.30
Location	Land Side
Category	Earthen Levee
Item	Vegetation
RD 536 Landside slope. Photo taken 4-24-2012.	
phillips_s_20120524_462.jpg

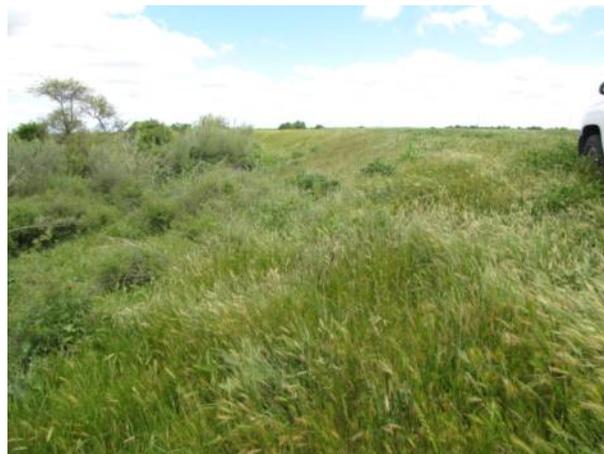
Levee Mile Report Line	18
Start Levee Mile	1.56
End Levee Mile	4.64
Location	Water Side
Category	Earthen Levee
Item	Vegetation
RD 536 Looking downstream waterside slope. Photo taken 4-24-2012.	
phillips_s_20120524_463.jpg

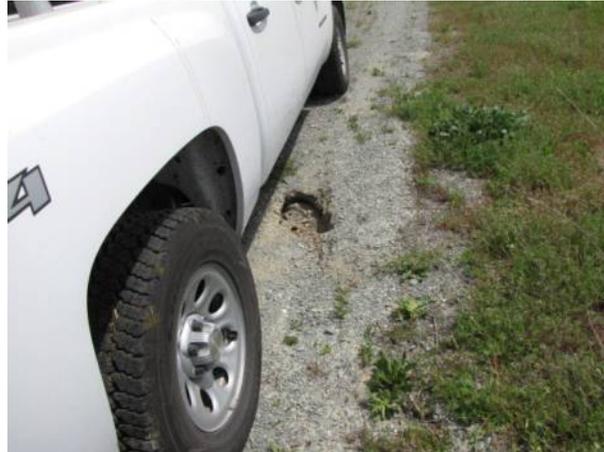
Levee Mile Report Line	21
Start Levee Mile	2.68
End Levee Mile	2.68
Location	Crown
Category	Earthen Levee
Item	Cracking
Hole in crown roadway landside shoulder. Photo taken 4-24-2012.	
phillips_s_20120524_465.jpg

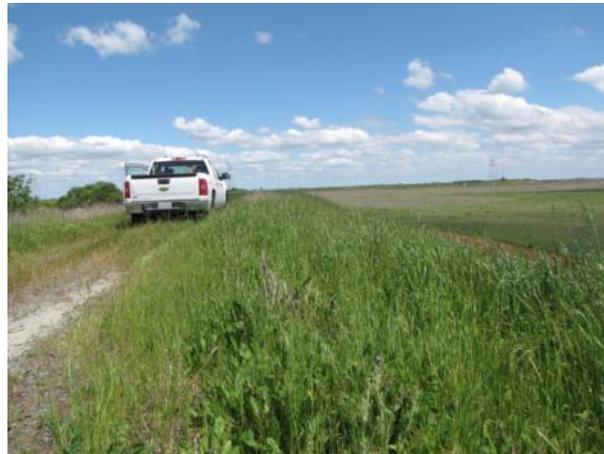
Levee Mile Report Line	25
Start Levee Mile	2.73
End Levee Mile	4.68
Location	Land Side
Category	Earthen Levee
Item	Vegetation
Looking downstream landward slope levee mile 2.73. Photo taken 4-24-2012.	
phillips_s_20120524_468.jpg

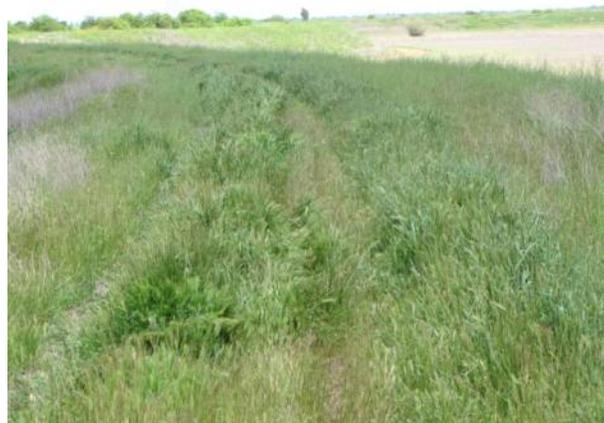
Levee Mile Report Line	26
Start Levee Mile	2.75
End Levee Mile	4.65
Location	Crown
Category	Earthen Levee
Item	Crown Surface / Depressions / Rutting
Levee mile 2.75-4.65 crown roadway looking downstream. Photo taken 4-24-2012.	
phillips_s_20120524_466.jpg

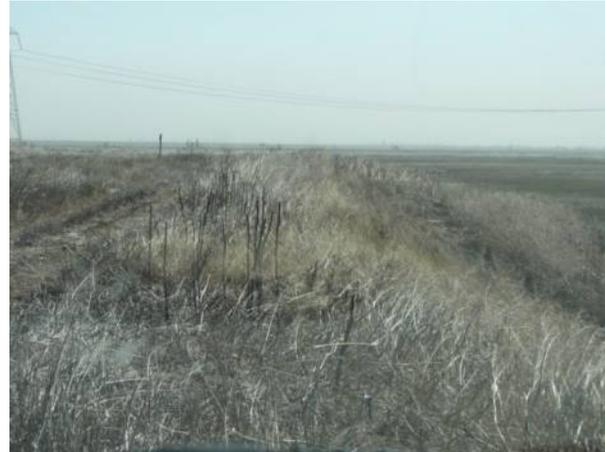
Levee Mile Report Line	27
Start Levee Mile	2.85
End Levee Mile	3.74
Location	Land Side
Category	Earthen Levee
Item	Vegetation
Looking downstream landside unit 1 levee mile 2.85 to levee mile 3.74. Photo taken 11-01-2011.	
phillips_s_20120306_211.jpg

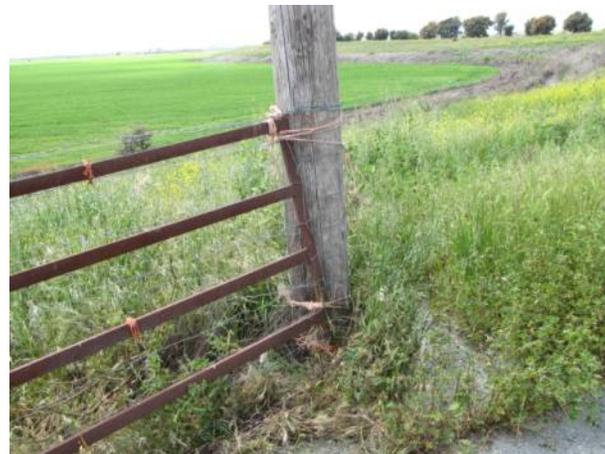
Levee Mile Report Line	29
Start Levee Mile	3.68
End Levee Mile	3.68
Location	Crown
Category	Earthen Levee
Item	Repair Gates
Repair this gate someone could get hurt trying to open and close this gate. 4-24-2012.	
phillips_s_20120524_471.jpg

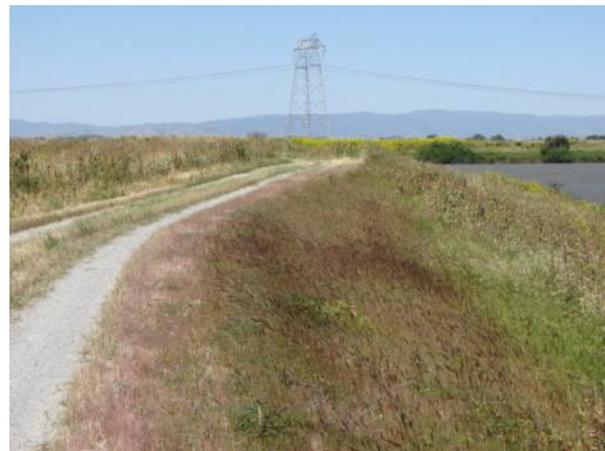
Levee Mile Report Line	32
Start Levee Mile	4.19
End Levee Mile	4.26
Location	Water Side
Category	Earthen Levee
Item	Vegetation
Looking upstream from levee mile 4.21.	
phillips_s_20120306_212.jpg

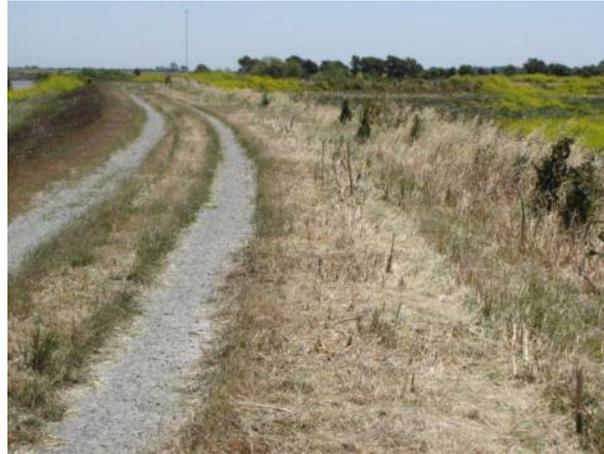
Looking downstream from levee mile 4.21

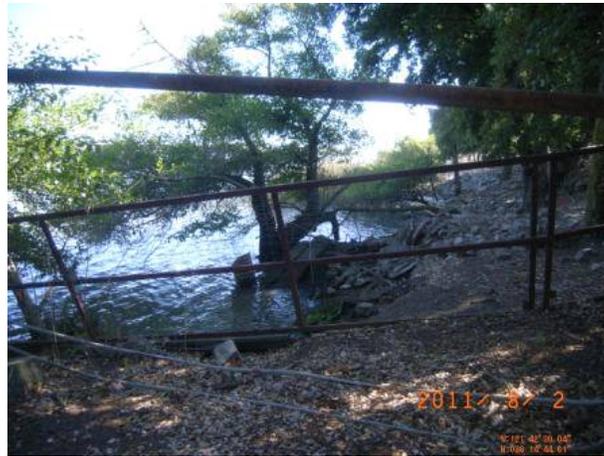
USACE 2011 Photo #1

Levee Mile Report Line	36
Start Levee Mile	4.83
End Levee Mile	4.86
Location	Water Side
Category	Supplemental
Item	USACE Erosion Survey

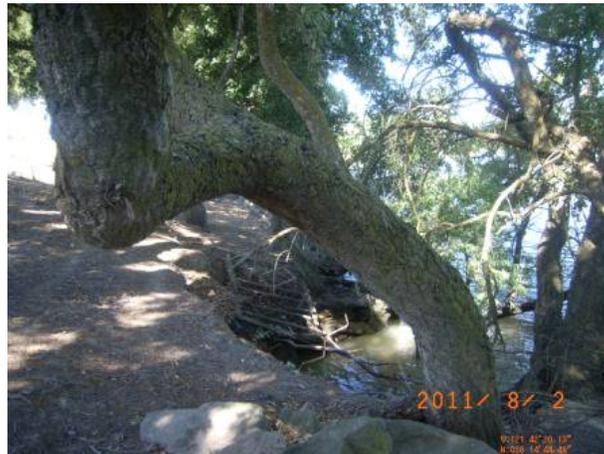
USACE 2011 Photo #2

Levee Mile Report Line	36
Start Levee Mile	4.83
End Levee Mile	4.86
Location	Water Side
Category	Supplemental
Item	USACE Erosion Survey

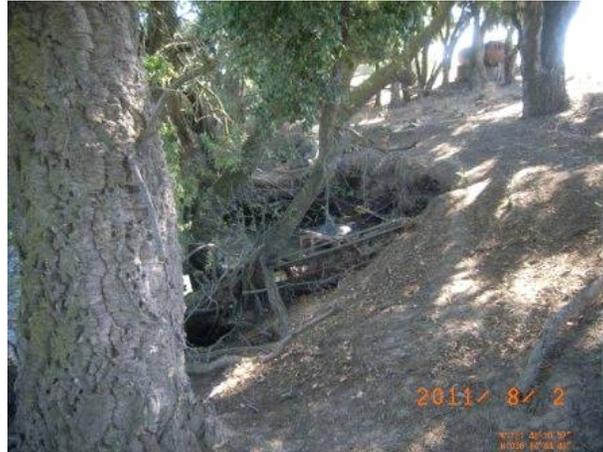
Levee Mile Report Line	36
Start Levee Mile	4.83
End Levee Mile	4.86
Location	Water Side
Category	Supplemental
Item	USACE Erosion Survey
USACE 2011 Photo #3	
phillips_s_20120306_209.jpg

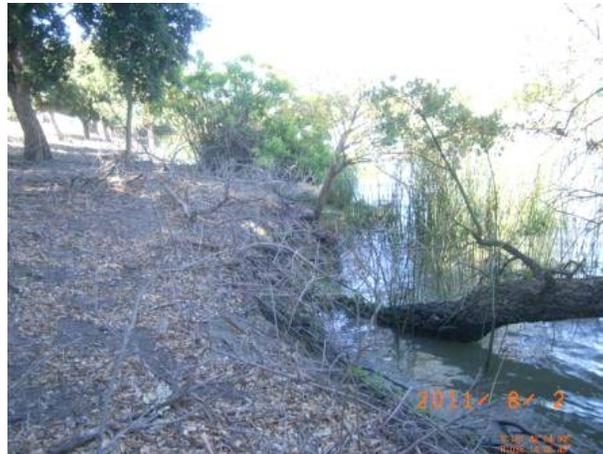
DWR ID: DWR_RD0536_01_s_2012_16										
37	4.90	5.03	Supplemental	USACE Erosion Survey	WS	M Ma	Inspector Comments: 2011: Levee toe is unraveling with large slumping sections. This site is downstream of old bank rock. [2011 Site ID: LDS_0-7_R]	38.245981 ° -121.707609 °	38.246326 ° -121.706737 °	25 Y
DWR ID: DWR_RD0536_01_s_2012_25										
38	4.90	4.94	Earthen Levee	Vegetation	WS	C Ma	V2 : Remove the wild growth other than native grasses from the levee slopes.	38.245427 ° -121.708922 °	38.245597 ° -121.708290 °	26
DWR ID: DWR_RD0536_01_s_2012_26										
39	5.19	5.46	Earthen Levee	Vegetation	WS	U Ma	V2 : Remove the wild growth other than native grasses from the levee slopes.	38.245225 ° -121.704660 °	38.245622 ° -121.699617 °	24 Y
DWR ID: DWR_RD0536_01_s_2012_24										
40	5.21	5.40	Earthen Levee	Vegetation	LS	M Ma	V2 : Remove the wild growth other than native grasses from the levee slopes.	38.245339 ° -121.704304 °	38.245786 ° -121.700859 °	29

Levee Mile Report Line	37
Start Levee Mile	4.90
End Levee Mile	5.03
Location	Water Side
Category	Supplemental
Item	USACE Erosion Survey
USACE 2011 Photo #1	
phillips_s_20120306_214.jpg

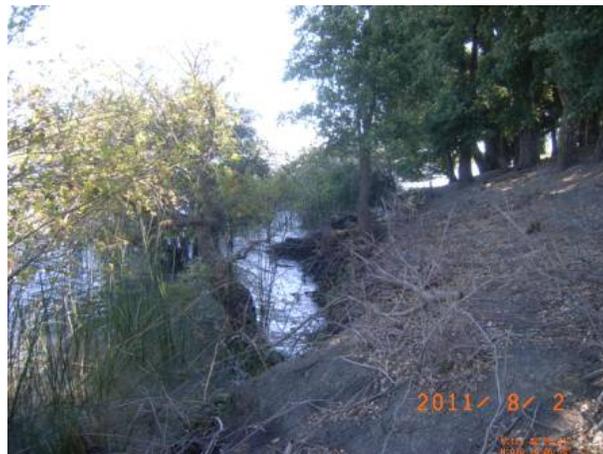
Levee Mile Report Line	37
Start Levee Mile	4.90
End Levee Mile	5.03
Location	Water Side
Category	Supplemental
Item	USACE Erosion Survey
USACE 2011 Photo #2	
phillips_s_20120306_215.jpg

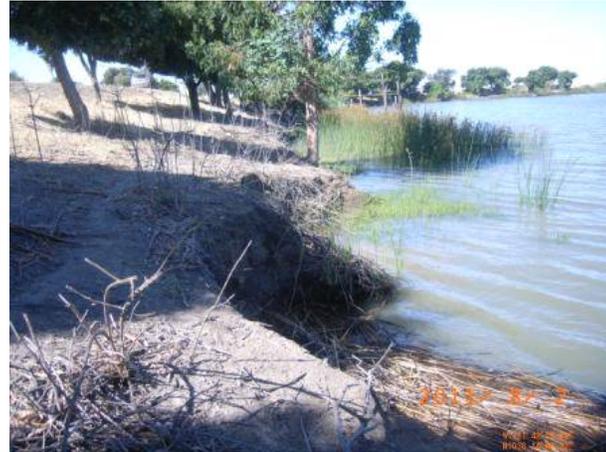
Levee Mile Report Line	37
Start Levee Mile	4.90
End Levee Mile	5.03
Location	Water Side
Category	Supplemental
Item	USACE Erosion Survey
USACE 2011 Photo #3	
phillips_s_20120306_216.jpg

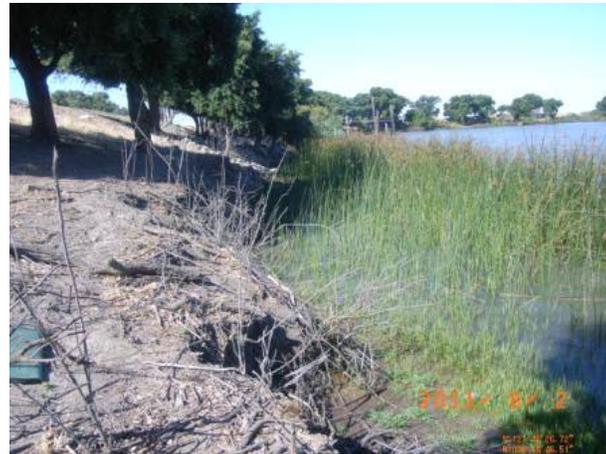
Levee Mile Report Line	37
Start Levee Mile	4.90
End Levee Mile	5.03
Location	Water Side
Category	Supplemental
Item	USACE Erosion Survey
USACE 2011 Photo #4	
phillips_s_20120306_217.jpg

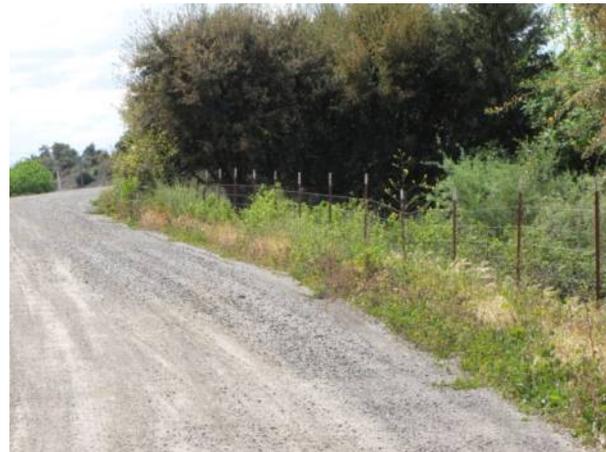
Levee Mile Report Line	39
Start Levee Mile	5.19
End Levee Mile	5.46
Location	Water Side
Category	Earthen Levee
Item	Vegetation
Overgrown slope waterward levee mile 5.19-5.46. Photo taken 4-24-2012.	
phillips_s_20120524_470.jpg

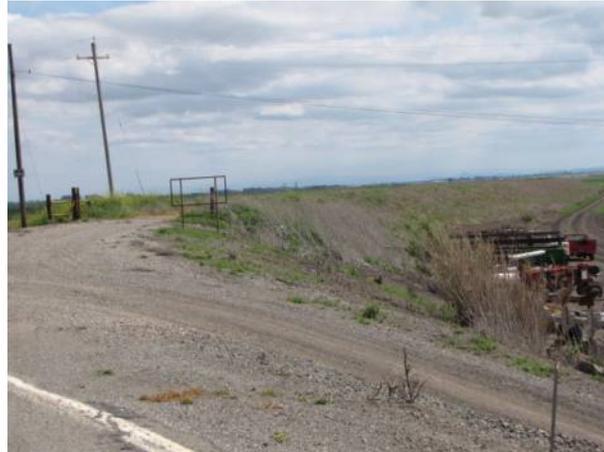
Levee Mile Report Line	1
Start Levee Mile	0.00
End Levee Mile	0.00
Location	Land Side
Category	Earthen Levee
Item	Vegetation
Looking downstream from levee mile 0.00 Unit 2 RD 536 landside. Photo taken 4-24-2012.	
phillips_s_20120524_472.jpg

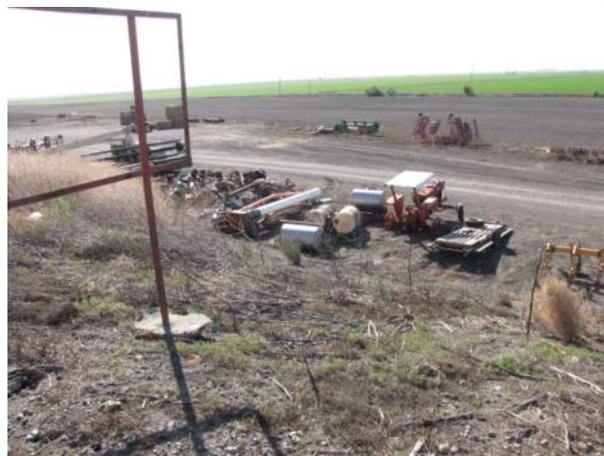
Levee Mile Report Line	2
Start Levee Mile	0.01
End Levee Mile	0.06
Location	Land Side
Category	Earthen Levee
Item	Encroachments
Photo showing equipment within 10-foot of landward toe. Photo taken 11-01-2011.	
phillips_s_20120306_221.jpg

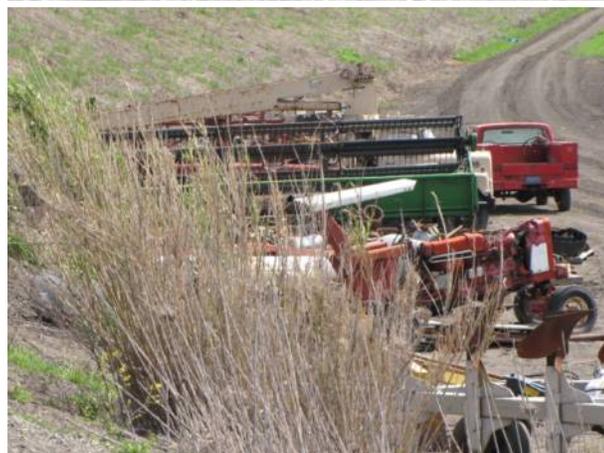
Levee Mile Report Line	2
Start Levee Mile	0.01
End Levee Mile	0.06
Location	Land Side
Category	Earthen Levee
Item	Encroachments
Unauthorized encroachments on landward within 10-foot of the toe. Photo taken 4-24-2012.	
phillips_s_20120524_473.jpg

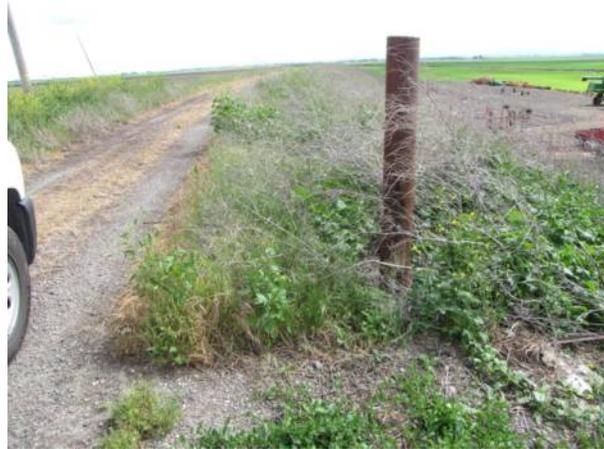
Levee Mile Report Line	3
Start Levee Mile	0.04
End Levee Mile	0.10
Location	Land Side
Category	Earthen Levee
Item	Vegetation
Looking downstream landside shoulder and slope levee miles 0.04-0.10. Photo taken 4-24-2012.	
phillips_s_20120525_474.jpg

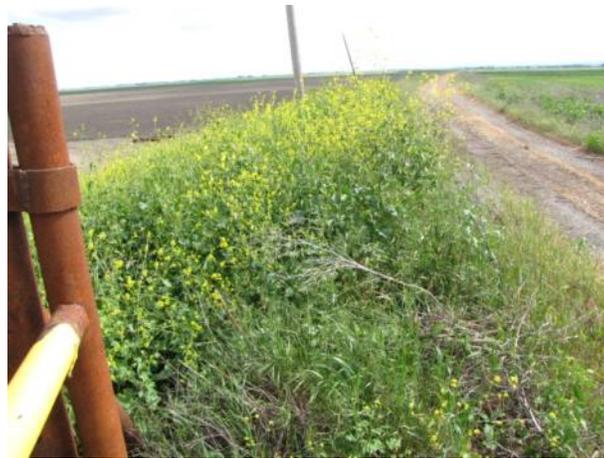
Levee Mile Report Line	4
Start Levee Mile	0.04
End Levee Mile	0.10
Location	Water Side
Category	Earthen Levee
Item	Vegetation
Looking downstream waterside shoulder and slope. Photo taken 4-24-2012.	
phillips_s_20120525_475.jpg

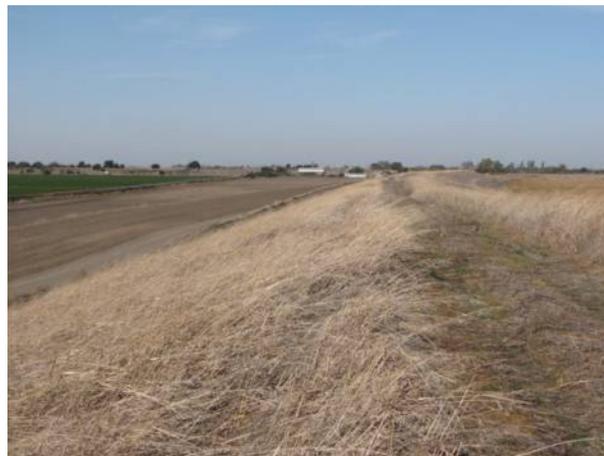
Levee Mile Report Line	9
Start Levee Mile	0.11
End Levee Mile	2.03
Location	Water Side
Category	Earthen Levee
Item	Vegetation
Unsatisfactory growth on landward slope looking upstream from levee mile 2.03 to levee mile 0.11. Photo taken 11-01-2011.	
phillips_s_20120306_228.jpg

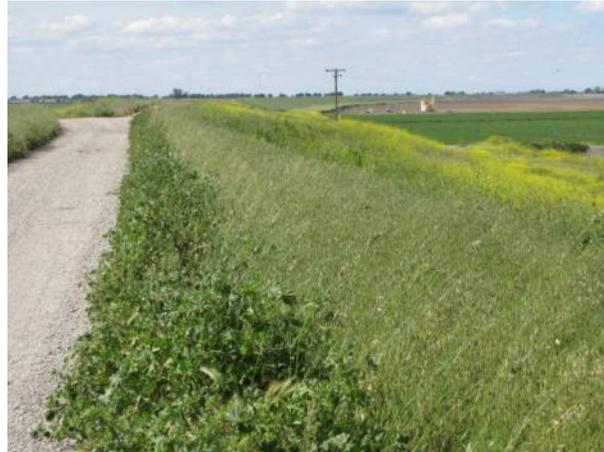
Levee Mile Report Line	9
Start Levee Mile	0.11
End Levee Mile	2.03
Location	Water Side
Category	Earthen Levee
Item	Vegetation
Levee mile 2.03 looking back upstream to levee mile 0.11. Photo taken 4-24-2012.	
phillips_s_20120525_476.jpg

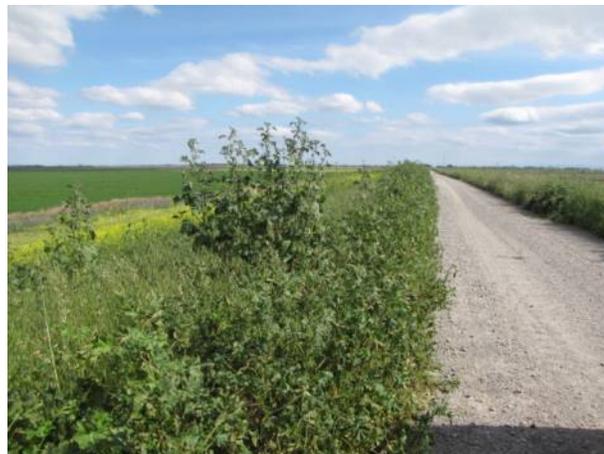
Levee Mile Report Line	14
Start Levee Mile	2.18
End Levee Mile	3.07
Location	Water Side
Category	Earthen Levee
Item	Vegetation
Looking downstream waterside levee mile 2.18-3.07. Photo taken 4-24-2012.	
phillips_s_20120525_477.jpg

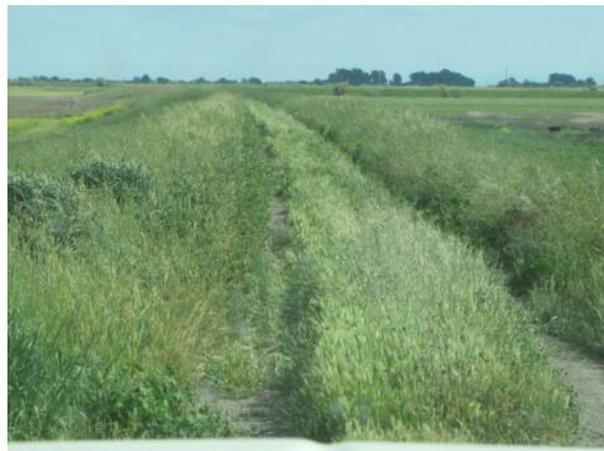
Levee Mile Report Line	15
Start Levee Mile	2.22
End Levee Mile	2.98
Location	Crown
Category	Earthen Levee
Item	Crown Surface / Depressions / Rutting
Looking downstream levee mile 2.22-2.95 crown roadway. Photo taken 4-24-2012.	
phillips_s_20120525_479.jpg

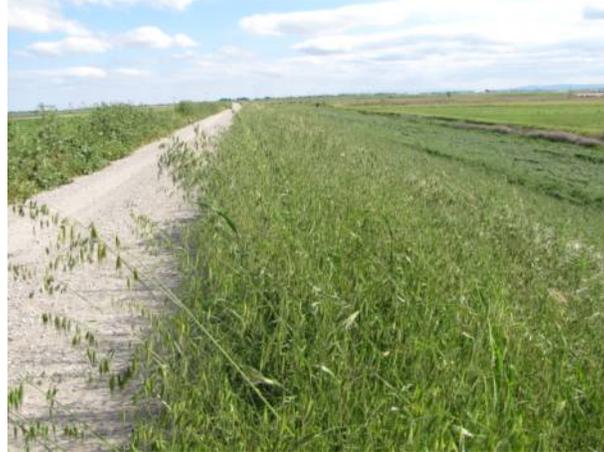
Levee Mile Report Line	16
Start Levee Mile	2.22
End Levee Mile	2.85
Location	Land Side
Category	Earthen Levee
Item	Vegetation
Looking downstream landside levee miles 2.22-2.85. Photo taken 4-24-2012.	
phillips_s_20120525_478.jpg
